The advances being made in vial processing

by John Erdner

John Erdner, product manager, aseptic fill-finish systems, SP Scientific PennTech, discusses the advances being made in vial processing to help reduce the risk of vial damage and particle contamination.

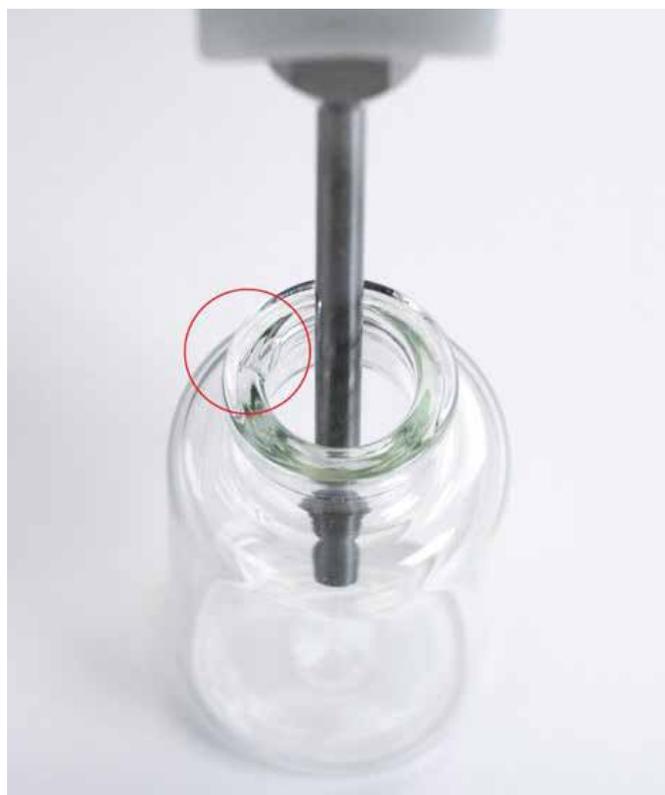
Figure 1: Chipped vial rim and resultant particulate generation

There has been at least one recall for parenteral products packaged in vials with chipped rim surfaces and a number of US Food & Drug Administration (FDA) 483 notices issued to pharmaceutical manufacturers for glass particles found in vials. When this occurs, it is obviously a critical event for the manufacturer of parenteral products. Sometimes these instances can go undetected - the vial progresses to filling, is stoppered and capped before inspection. If the vial is capped, this defect will be difficult to identify.

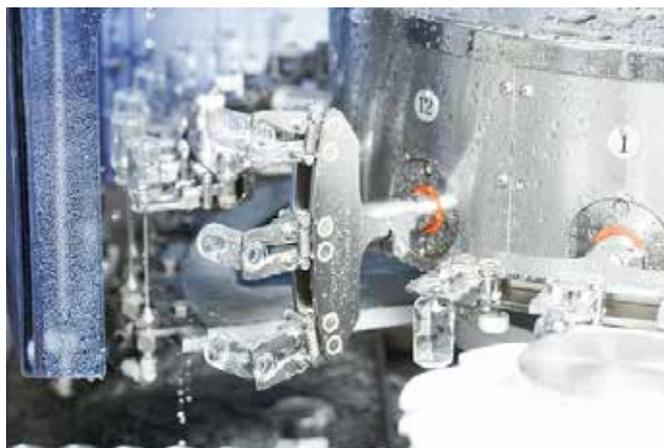
Figure 2: Modern washing and depyrogenation installation featuring washing needles

For small batch applications there are companies that provide a vial washer and tunnel suited to lower throughput processes of 50 vials per minute, or less. Modern systems (Figure 2) are compact, occupying 3m/9ft or less, and are sized for small batches giving the drug manufacturer complete control of the process, thus minimising the risks of human intervention and contamination.

Vials are usually manually unwrapped and loaded into vial washing machines, when the operators have the opportunity to identify damage or debris and remove the defective glass. Besides transport damage, another cause for chipped vials can be vial washers themselves. Many washing systems use stainless steel needles to transfer the washing

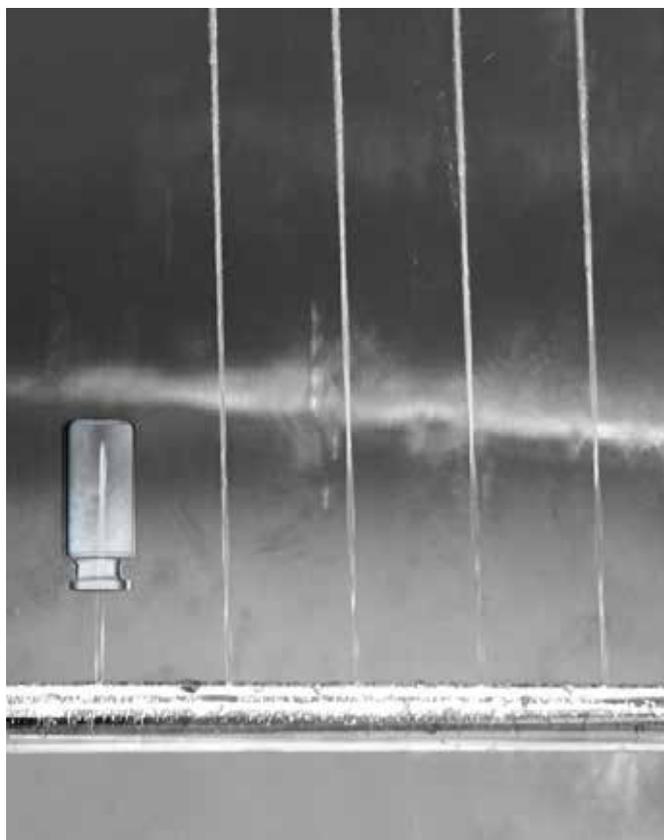
Figure 3: High Pressure Washing Jet Manifold for Vial Washing Without Needles

To achieve high vial throughputs, rotary washers have dozens of needles and some linear washers have hundreds of needles entering the vial multiple times during the washing process. A 2cc vial can have a neck opening as small as 7mm diameter and the spray nozzles may be as thick as 4mm,

leaving little clearance (Figure 3). Thin needles can easily be accidentally bent during storage or installation, or misaligned during set up or service. The result is that the needle impacts the rim of the vial causing chipping to the vial mouth and glass debris. This interaction between the needle and vial occurs inside the machine during the washing process and is virtually undetectable as the vial is filled, stoppered and capped, and depending on the closure used, may not even be detected during the final inspection process.

The most advanced vial washers have eliminated the use of needles entirely, yet still achieve a 3-log reduction of particles required by the FDA during vial washing. This is accomplished by positioning a vial above the washing manifold which has precisely machined orifices to generate a high velocity water jet. This design creates a water stream that maintains its convergent nature until it impacts the base of the vial (Figure 4), ultimately eliminating the risk of misalignment and therefore the chipping and debris associated with the use of washing needles.
